NOTICE TO MARINERS

Notice of activities associated with operations on Beatrice Offshore Wind Farm

Date of Issue	22/07/2022	Notice Number	NTM-BE-00034 Rev 02
---------------	------------	---------------	---------------------

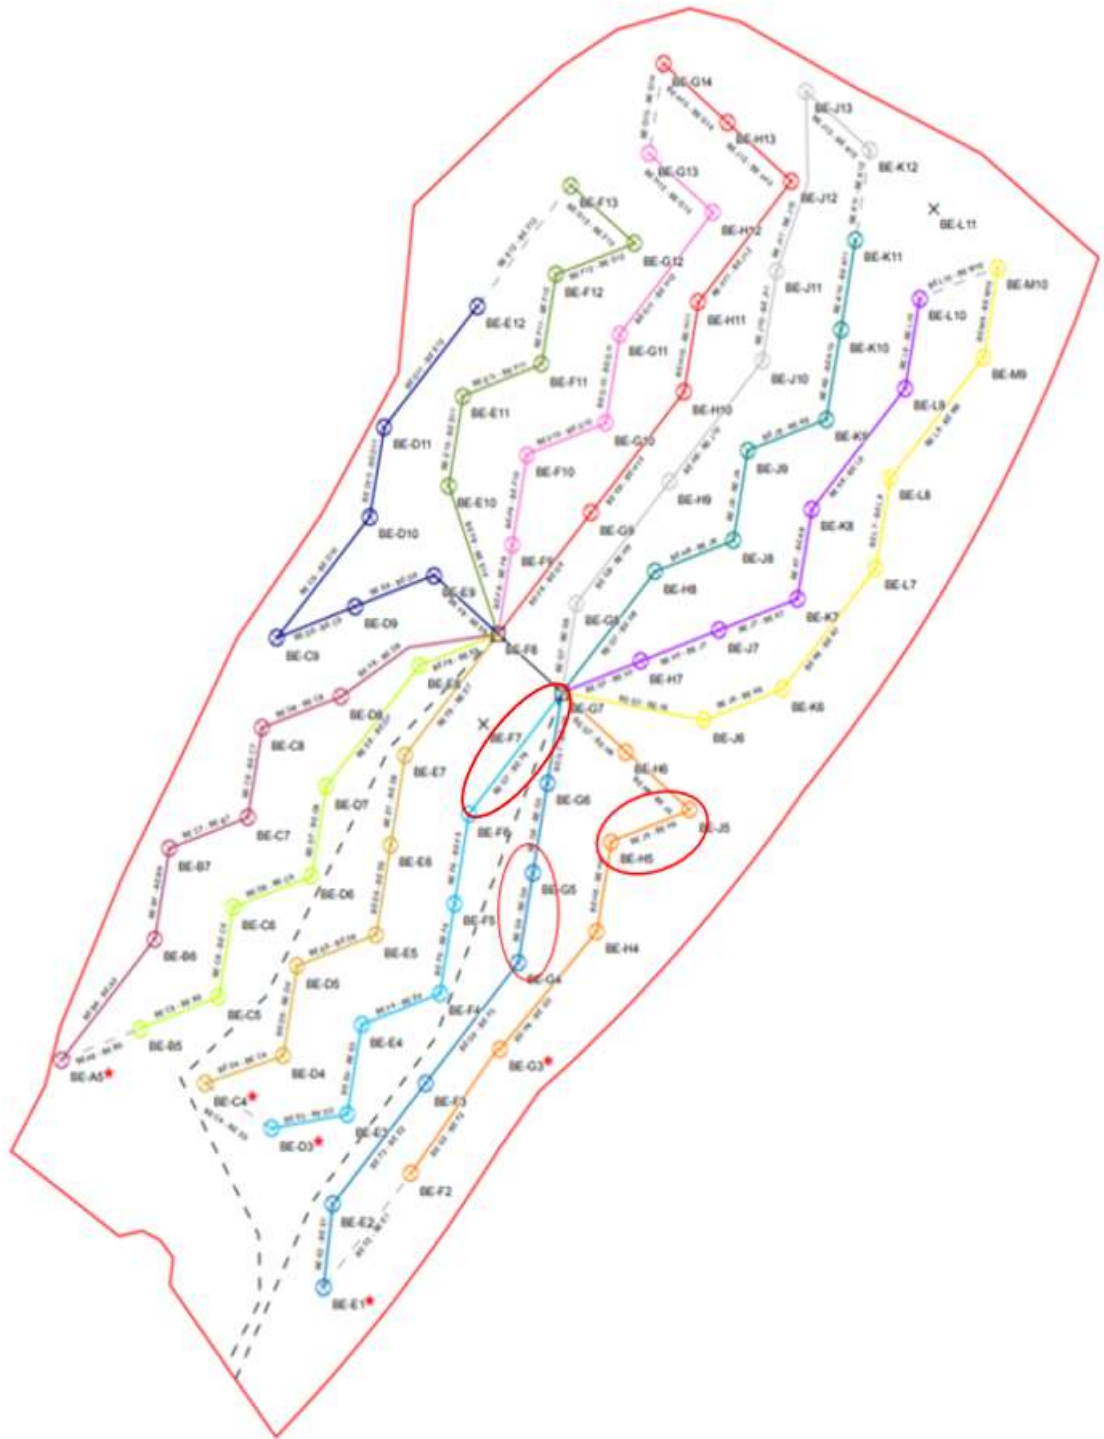
A further update is issued following recent asset surveys at BOWL, data indicates potential exposures at inter-array cables G4-G5 and G7-F6, between KP 0.627 to KP 0.669 and KP 2.04 to KP 2.046. Investigations are underway to confirm if exposures are present. There are also several sections with shallow burial depths as per the below tables. This NtM is being provided for information, further details will follow.

Figure 1- Cable Locations – Marked with red ellipse.
